Report #1

Prepared by: Michael Schwartz, Director
June 6th 2008

Report on emergency restoration work at Content Great House
using tranche 1 of funds

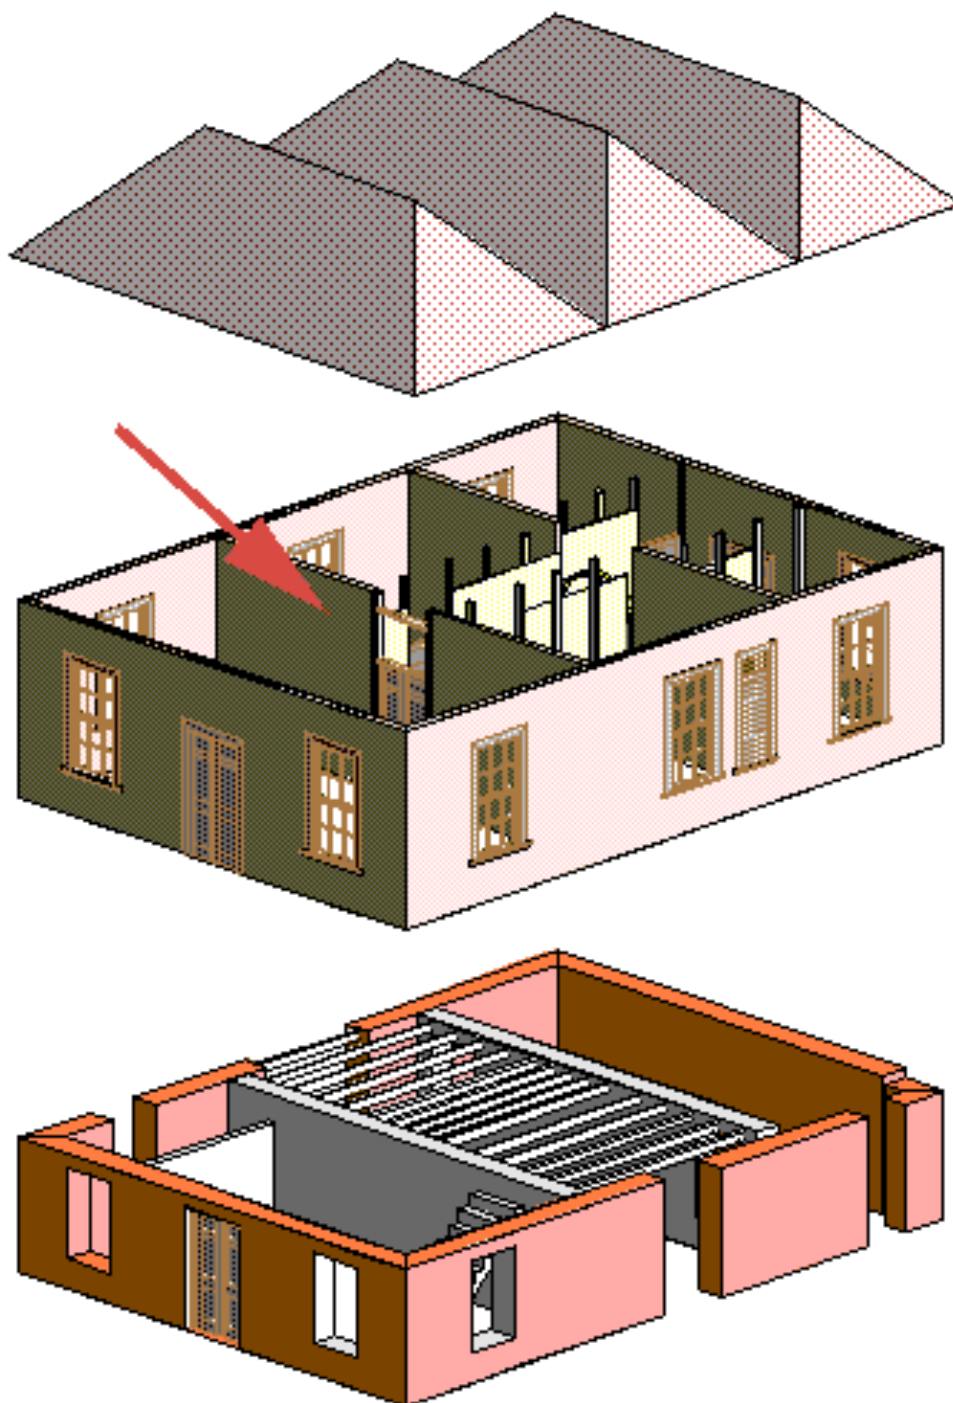
Figure 1

The following paragraphs refers to the Living Room interior wall (see Figure 1)

The red arrow shows the damaged wall.

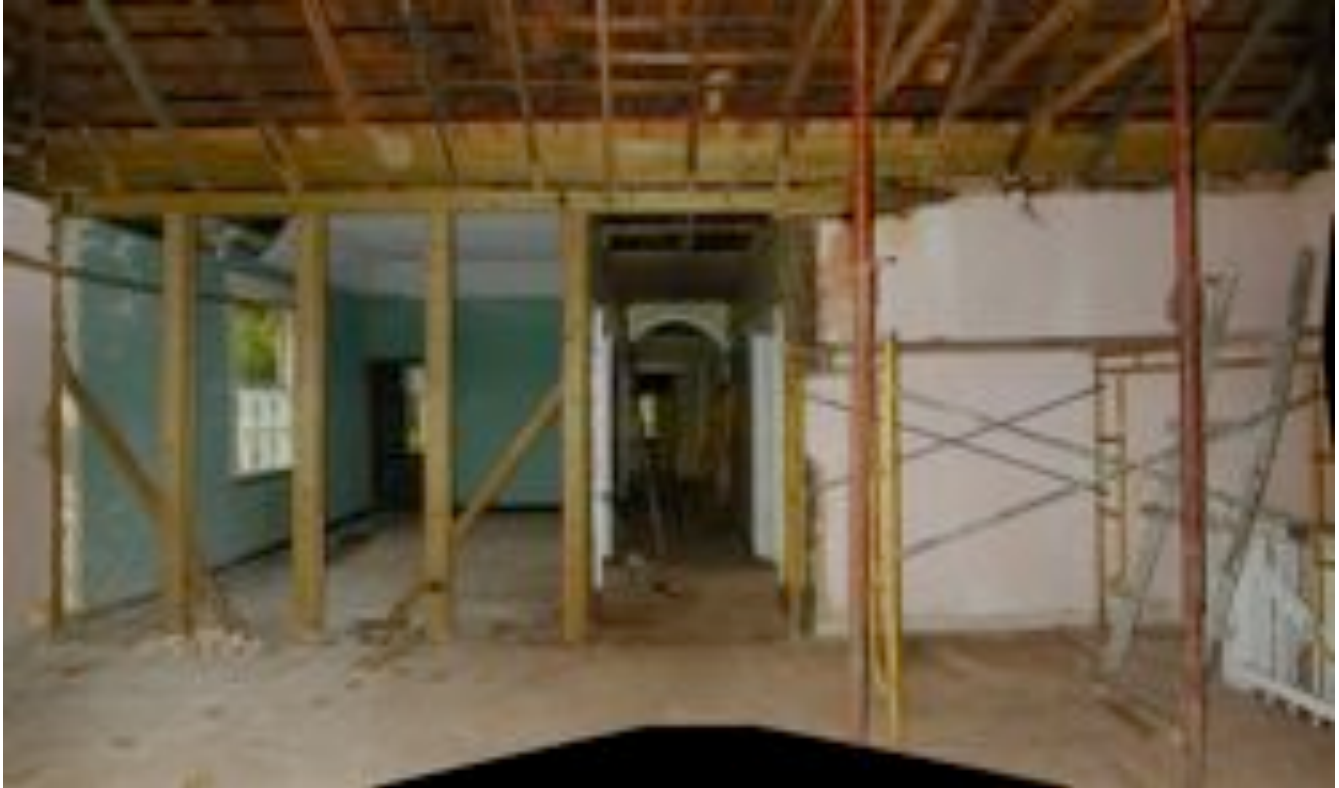
Figure 2 View of rebuilt wall structure in Living Room

1. After removing the tray ceilings, the western part of the interior wall was demolished. The eastern third seemed sound and currently has not been disturbed. The entire baseplate seemed sound and was not disturbed.

The structure was rebuilt using 3 thicknesses of 2 x 6 WPP to match the original timber frame width. Note that the central member of the posts uses 2 x 4 WPP so that there was a "key" for the masonry infill.

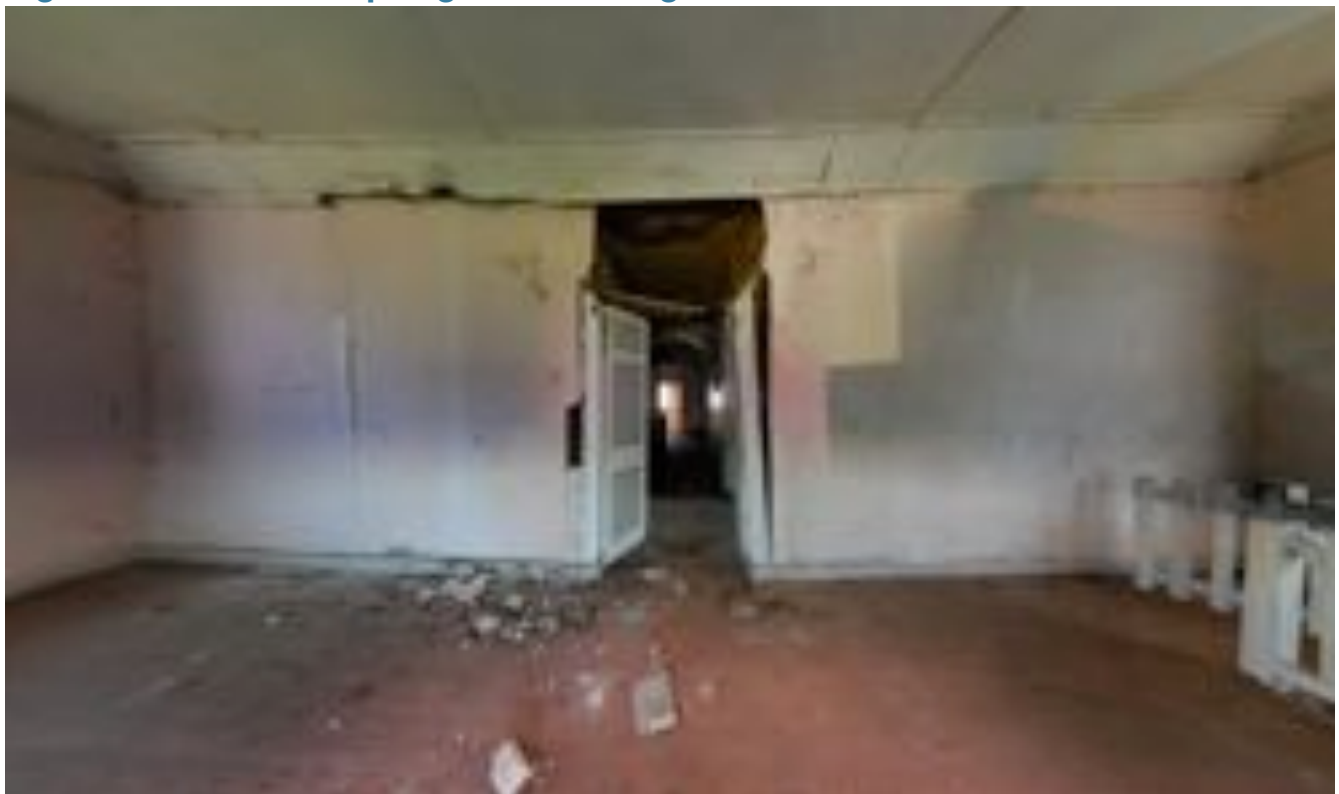
Figure 3 View of collapsing wall in Living Room before intervention

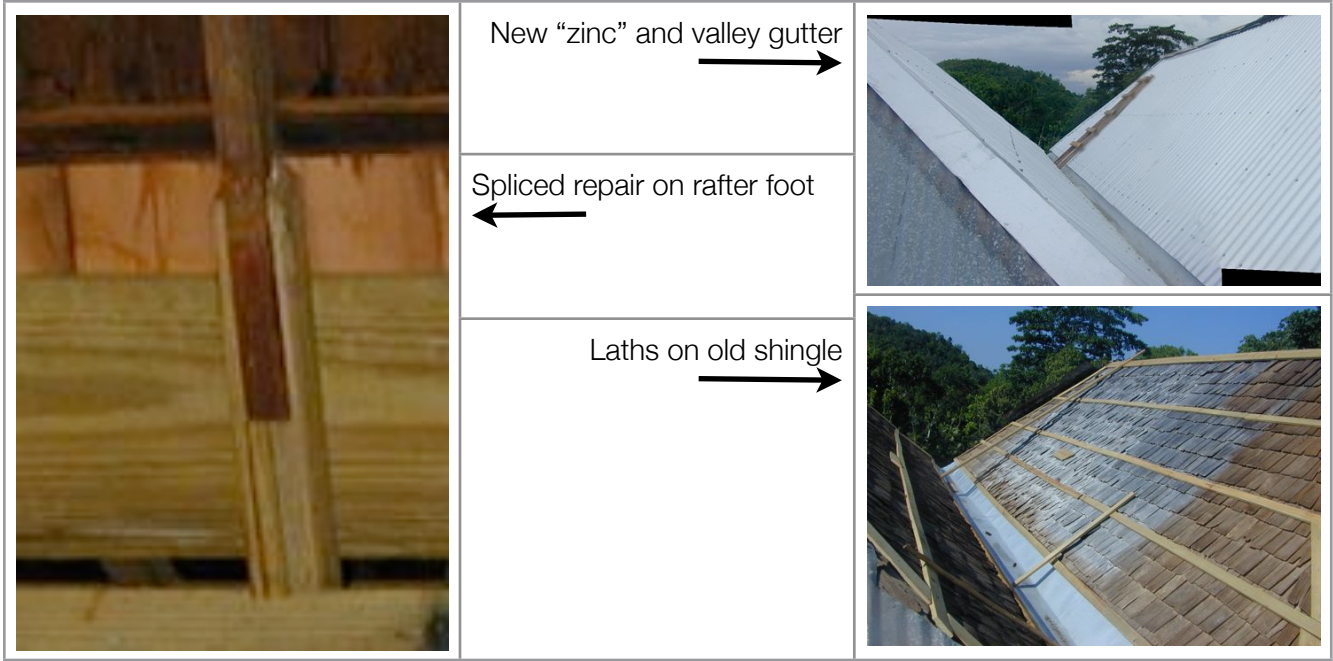
3. All rafter and hip feet in the affected area (northern wall) had rotted: in most cases, after jacking the roof trusses to the correct position, new ends were spliced on to existing lumber (see fig 4). Ten rafters were in such poor condition (mostly due to termite damage) that they were completely replaced, using local hardwoods (size was an issue as the original material was a full 2 in by 4 in.). Similarly, most of the roof ties were completely replaced (using WPP) as a result of termite damage.

Figure 4 Various snapshots of work done to date

5. The existing "zinc" was removed and lathes were nailed through the existing cedar shakes to rafters (see fig 4).

6. New Alu-zinc roofing was installed on the two slopes above the damaged wall (fig 4)

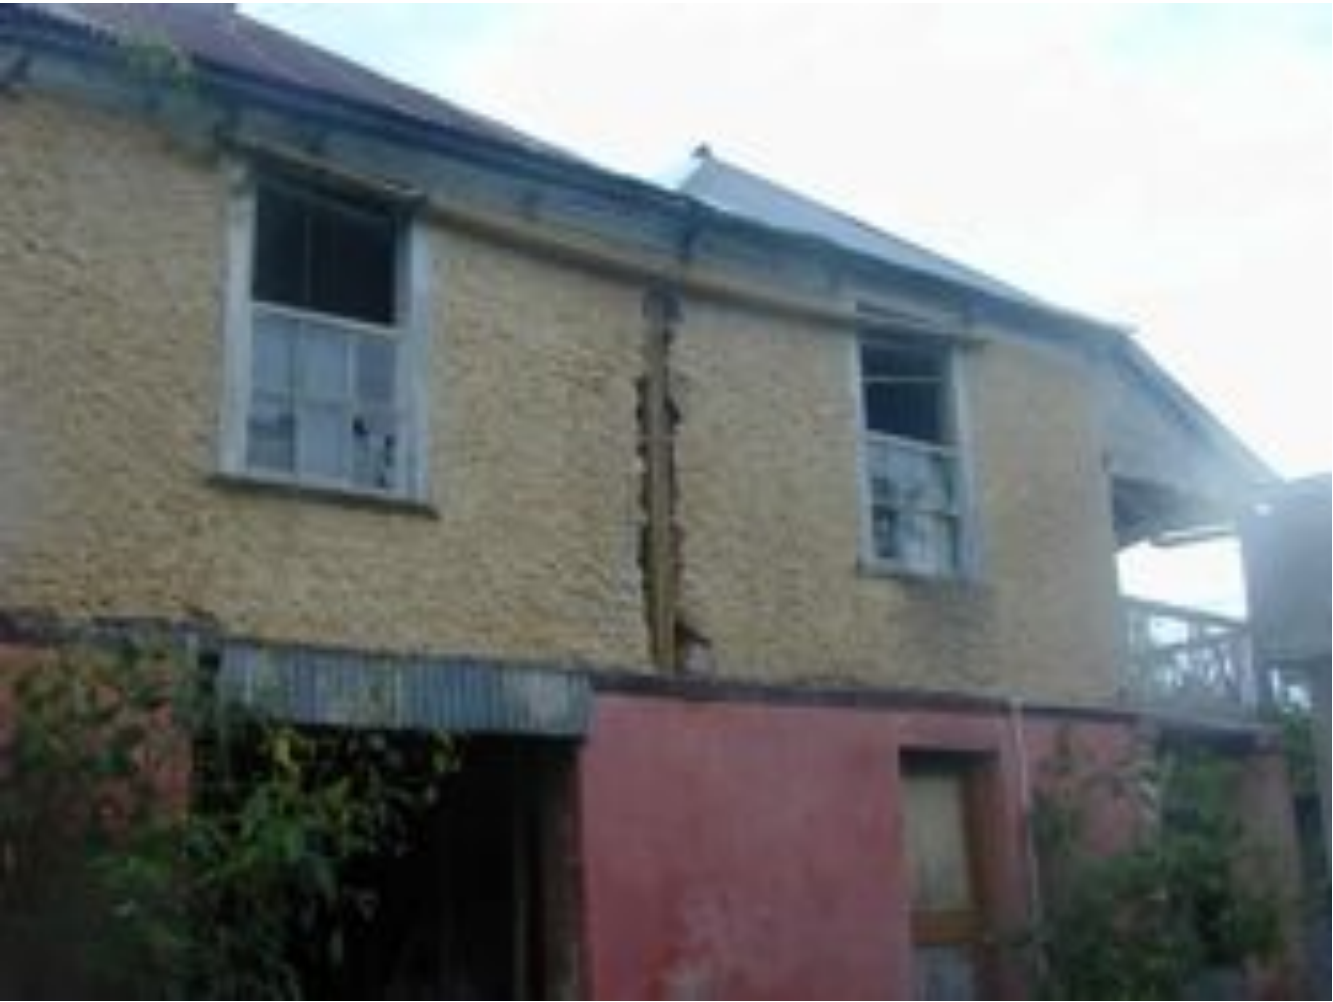
2. Rot was found to extend into the outer wall and one post together with approximately 14 ft of wallplate were replaced (see fig 5)

Figure 5 Photo of east side of house showing new post and clamps.
